ARE DARVIC COIL COLOUR RINGS SUITABLE FOR CAPE GANNETS?

Elizabeth Komen

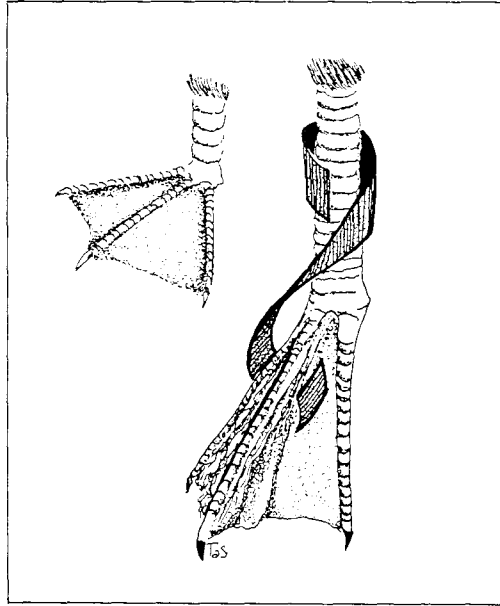
FIGURE 1

A number of colour-ringed birds had injured feet. Entirely atrophied right feet were also observed in some metal-ringed birds (colour rings missing). In most of the injured birds, the colour ring had slipped down and unwound around the foot, tightly constricting the web of the foot. In two cases the ring had pierced through the web of the foot (see Figure 1 overleaf). These 'unwound' rings artificially ankylose the tarsal/metatarsal joint causing atrophication of muscle, damaged nerve tissue, and necrosis of the foot by constriction of the blood supply. In effect the foot is usually permanently crippled.

A SCHEMATIC ILLUSTRATION OF COIL-RING DAMAGE TO
THE WEBBED FOOT OF A CAPE GANNET

This problem with Darvic coil rings in Cape Gannets has been observed elsewhere in southern Africa (R. Randall pers. comm., Colclough & Ross 1987). Although the coil colour rings may be lost or forcefully wound around the foot as a result of water resistance during plunge diving (Colclough & Ross 1987), it is also likely that newly-ringed gannets pull at the colour rings with their strong and sharply pointed beaks, causing them to open partially and snap back out of position (personal observations). Colclough & Ross (1987) have shown that the application of adhesives may not be wholly effective in preventing coil ring losses, and it is therefore recommended that some alternative non-coil ring-type is adopted in further colour-ringing studies of Cape Gannets. For example, the Darvic 'ring and corrosion-resistant rivet' system used until recently by the Vulture Study Group (Ledger 1974) or their new self-locking plastic rings (see Safring News 16 (1): p 38) may be more effective, and would certainly eliminate the incidence of foot injuries in Cape Gannets.
